## Try Acid

We borrowed a nice Mk1 Escort and chucked it in a load of acid to show you exactly what is involved in the process of acid dipping. Words: Ben Pics: Ben & SPL

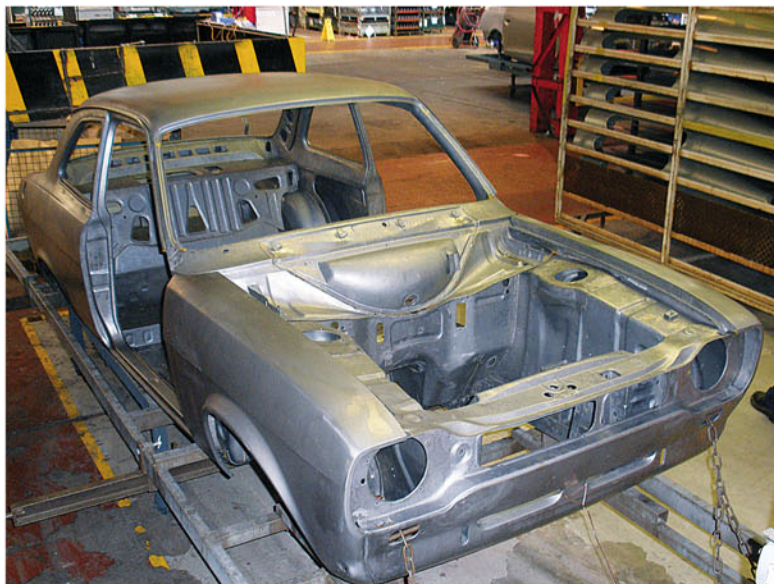
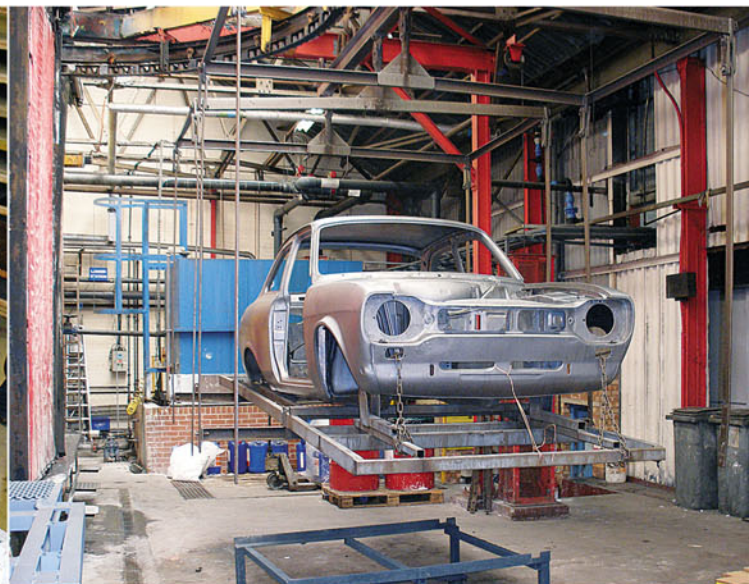
When going to be e-coated the shell is mounted on a cradle, chained down, wired and earthed ready for the 19 stages that are ahead

The shell gets securely mounted into a cage, where a conveyor takes it through this eleven stage process. It gets chained to a special cage, wired with an electric current and earthed through the cage. The pre-treatment process involves an initial de-grease which removes any silicone etc that may have come into contact with the shell since it came out of the final stage of the acid/alkali dipping process, and this is done in two stages. It is then rinsed twice with water, and a third time

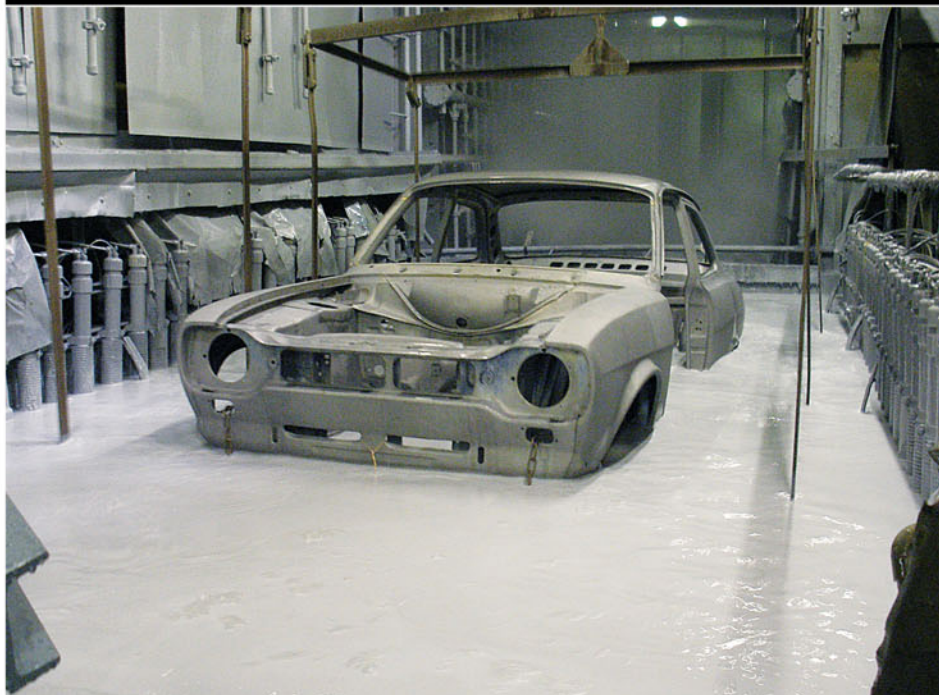
Below: It's almost like something out of the *Terminator* movies... The shell is lowered into the e-coat solution and stays there for 5 minutes

Once the clean-as-a-whistle shell has left the pre-treatment plant, the conveyor takes it around to an 8-metre long tank which contains 80,000 litres of cathodic electrocoat paint. Here the shell gets completely immersed and manipulated (jiggled about) within the tank coating cycle. It sits in the tank for around five minutes. The electrically charged shell attracts the electrocoat paint which causes it to cling to the shell. The final thickness of the primer coat will range from 17

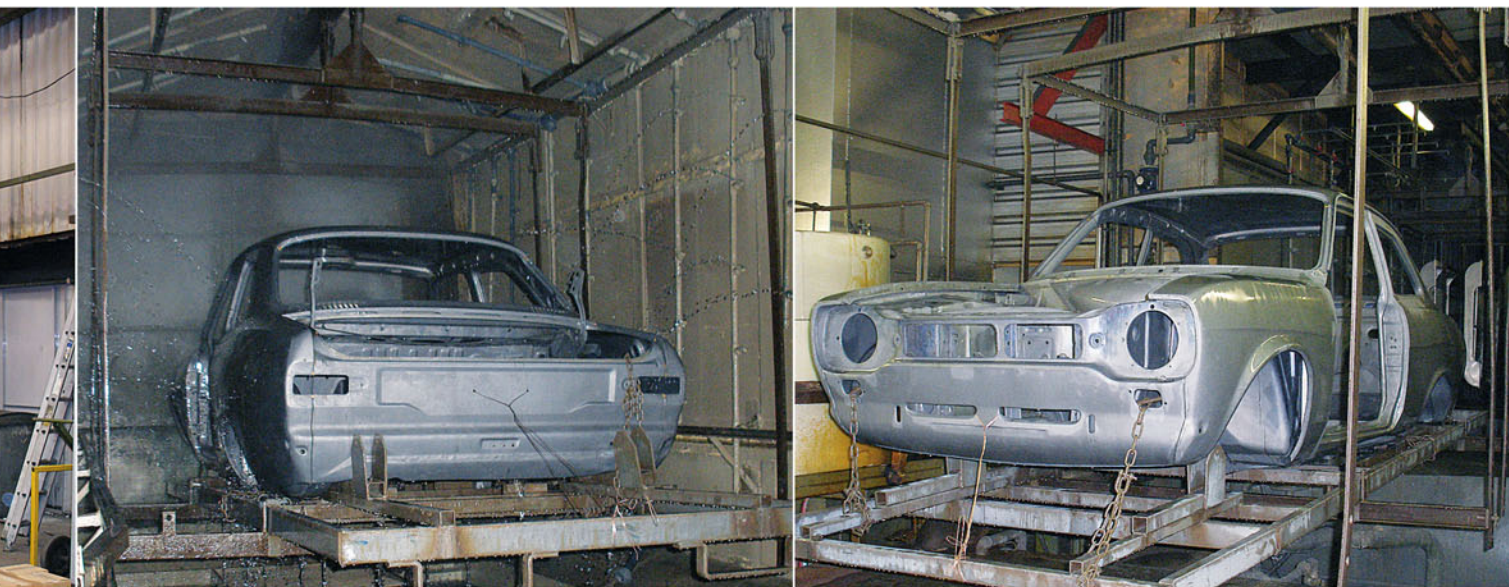
The shell gets washed many times in a variety of solutions to prepare it for the electrostatic dipping process. It's never been so clean!

with a special activating solution. Next it is rinsed with a tri-cationic phosphate solution which consists of zinc, nickel and manganese – all known to dispel the onset of corrosion. It again goes through two water rinsing stages. There is then a chromic rinse and finally a further two de-mineralised water rinses to leave the shell thoroughly clean and ready for the next stage.

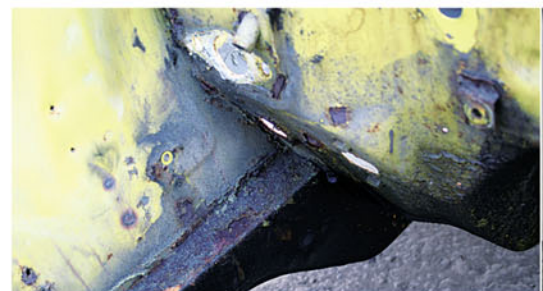
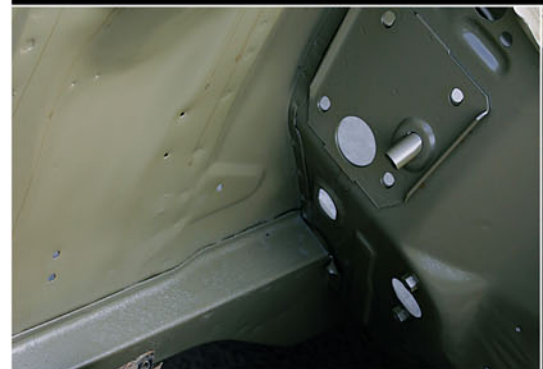
Before and after – what a huge difference

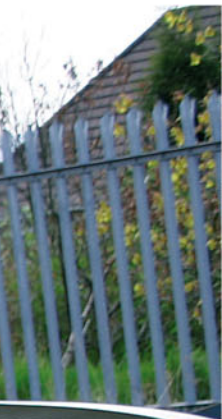
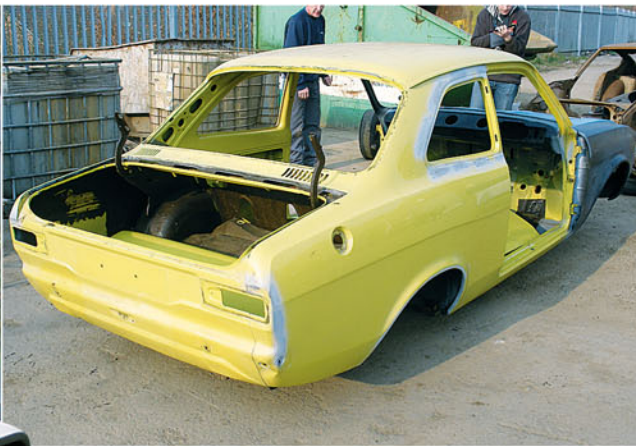
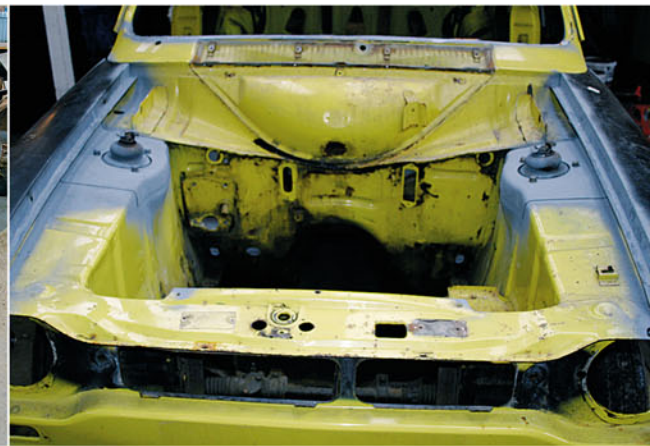
Here we can see the shell before it goes in, after the acid dip and then after it's had the e-coat treatment

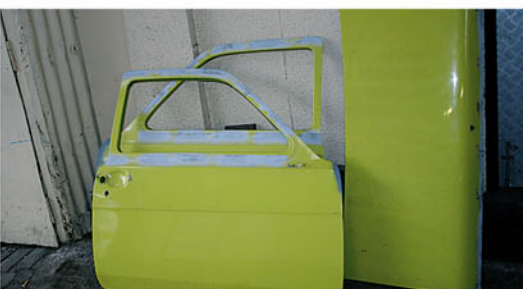
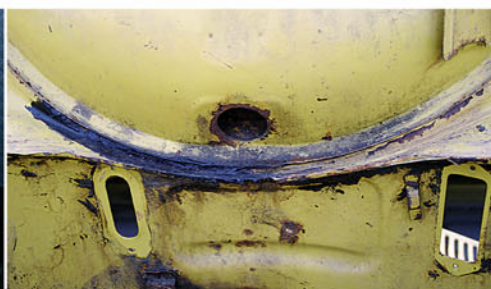
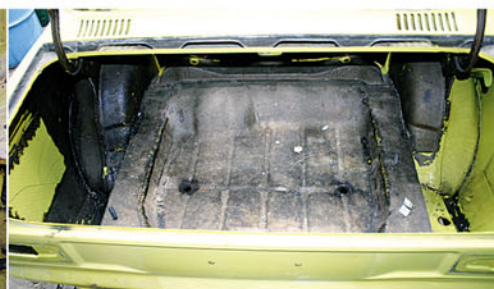
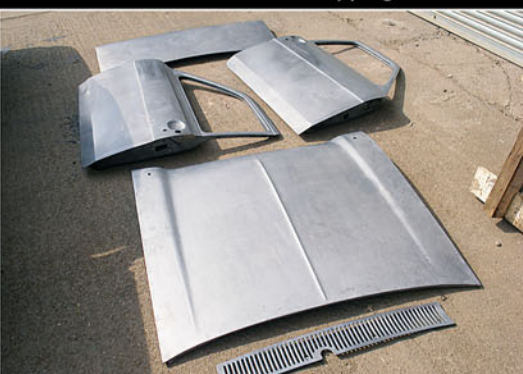
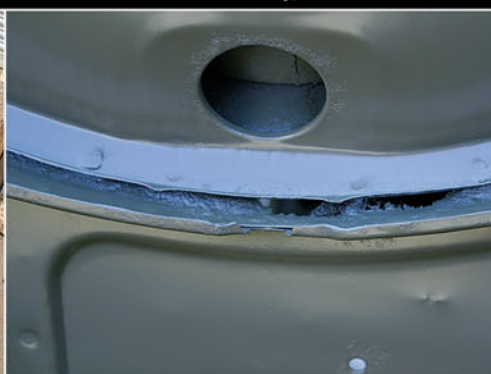
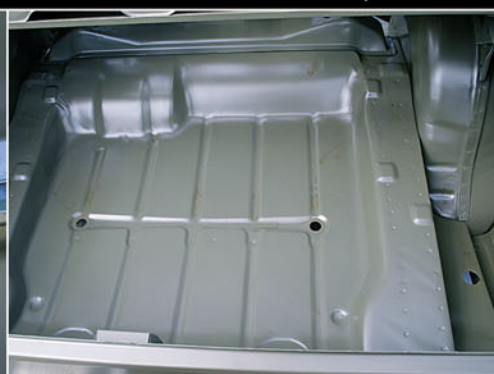
Panels before and after dipping – like new! Bulkhead looked a bit scabby, the acid reveals some minor holes. Ziebart in boot no problem!
